A PHOTOGRAPHIC SURVEY OF THE
WILMINGTON & WELDON RAILROAD CORRIDOR

VOLUME I

(Ruins at Wilmington, NC, 2000-2001)

James C. Burke

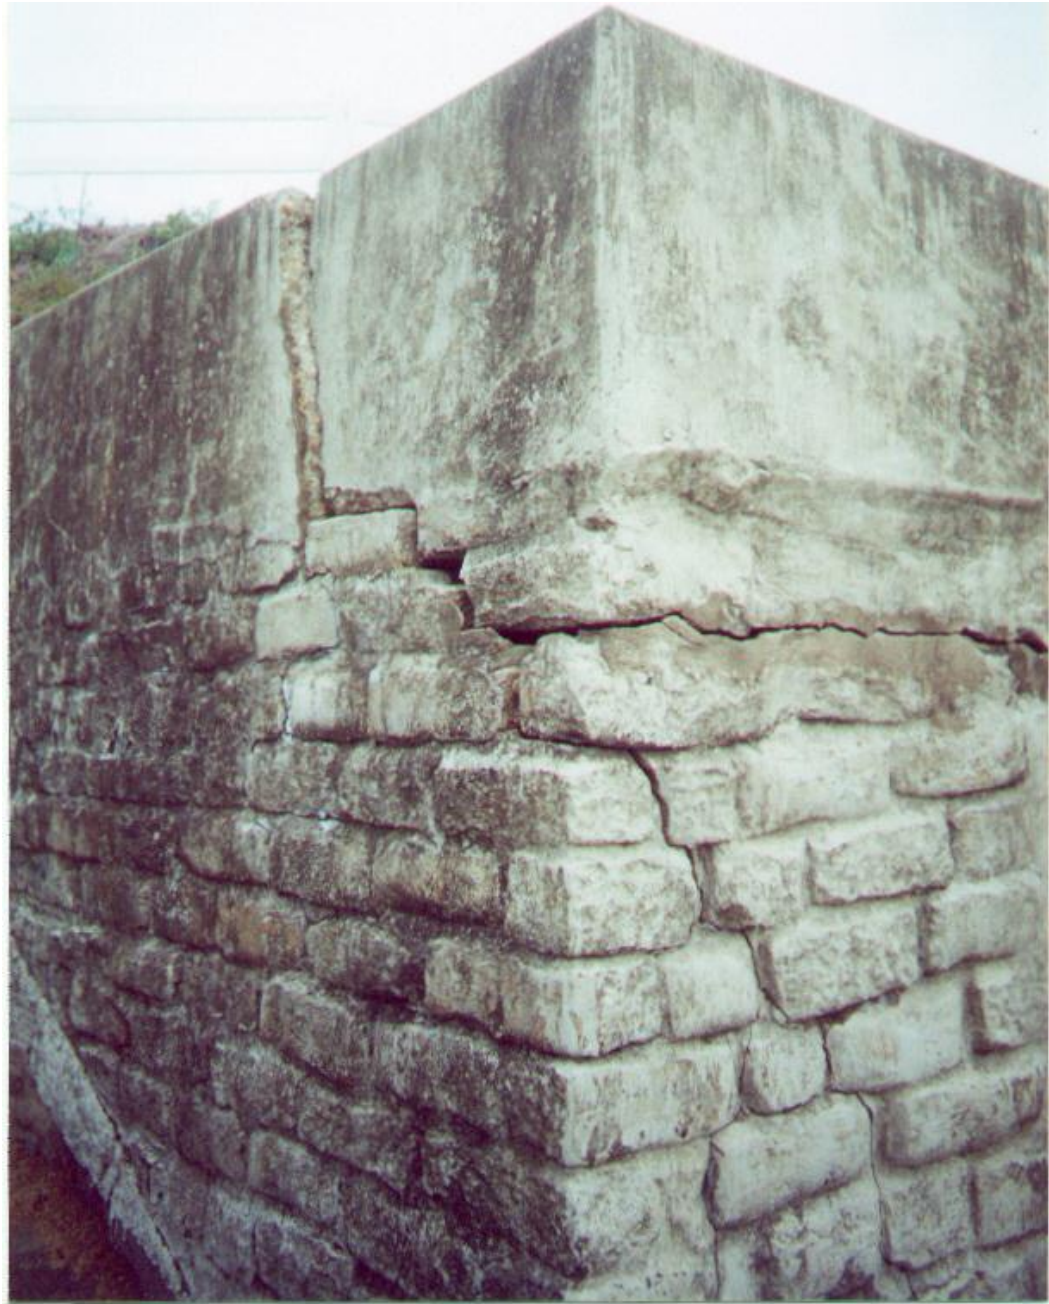
Figure 2

In this photograph, details of the masonry on the corner of the wall at the Nutt Street and Brunswick Street show that cracking and shifting have taken place. The stone base upon which the masonry rests can be seen in the lower left hand corner of the photograph. Separation of the concrete blocks on the crown of the corner is noticeable.

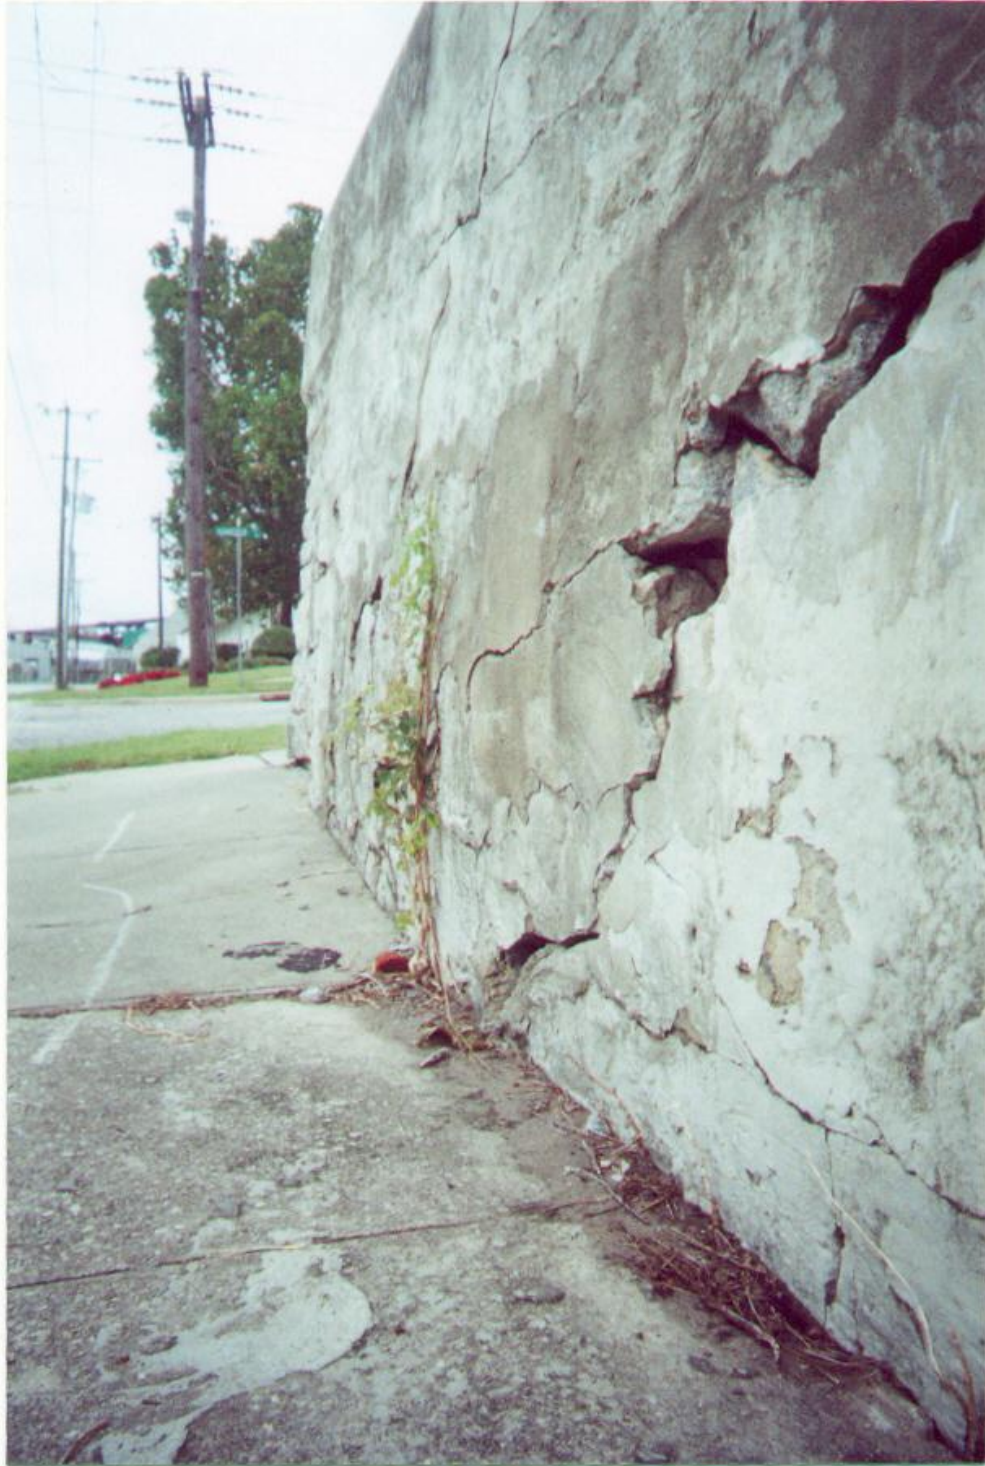
Figure 3

This photograph was taken from the sidewalk on Nutt Street looking towards the intersection of Nutt and Brunswick Streets. At this point, one can observe the wall being forced outward at its base. Interior elements of composite material are exposed between the cracks of surface material.

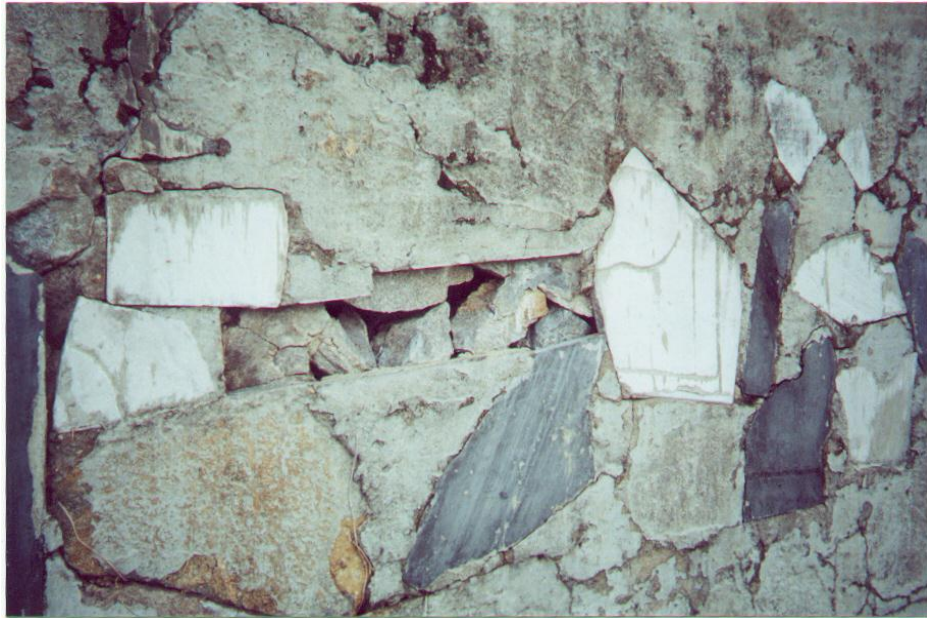
Figure 5

This photograph shows tile and slate wall surface. Some surface material has fallen off to expose loose interior elements.

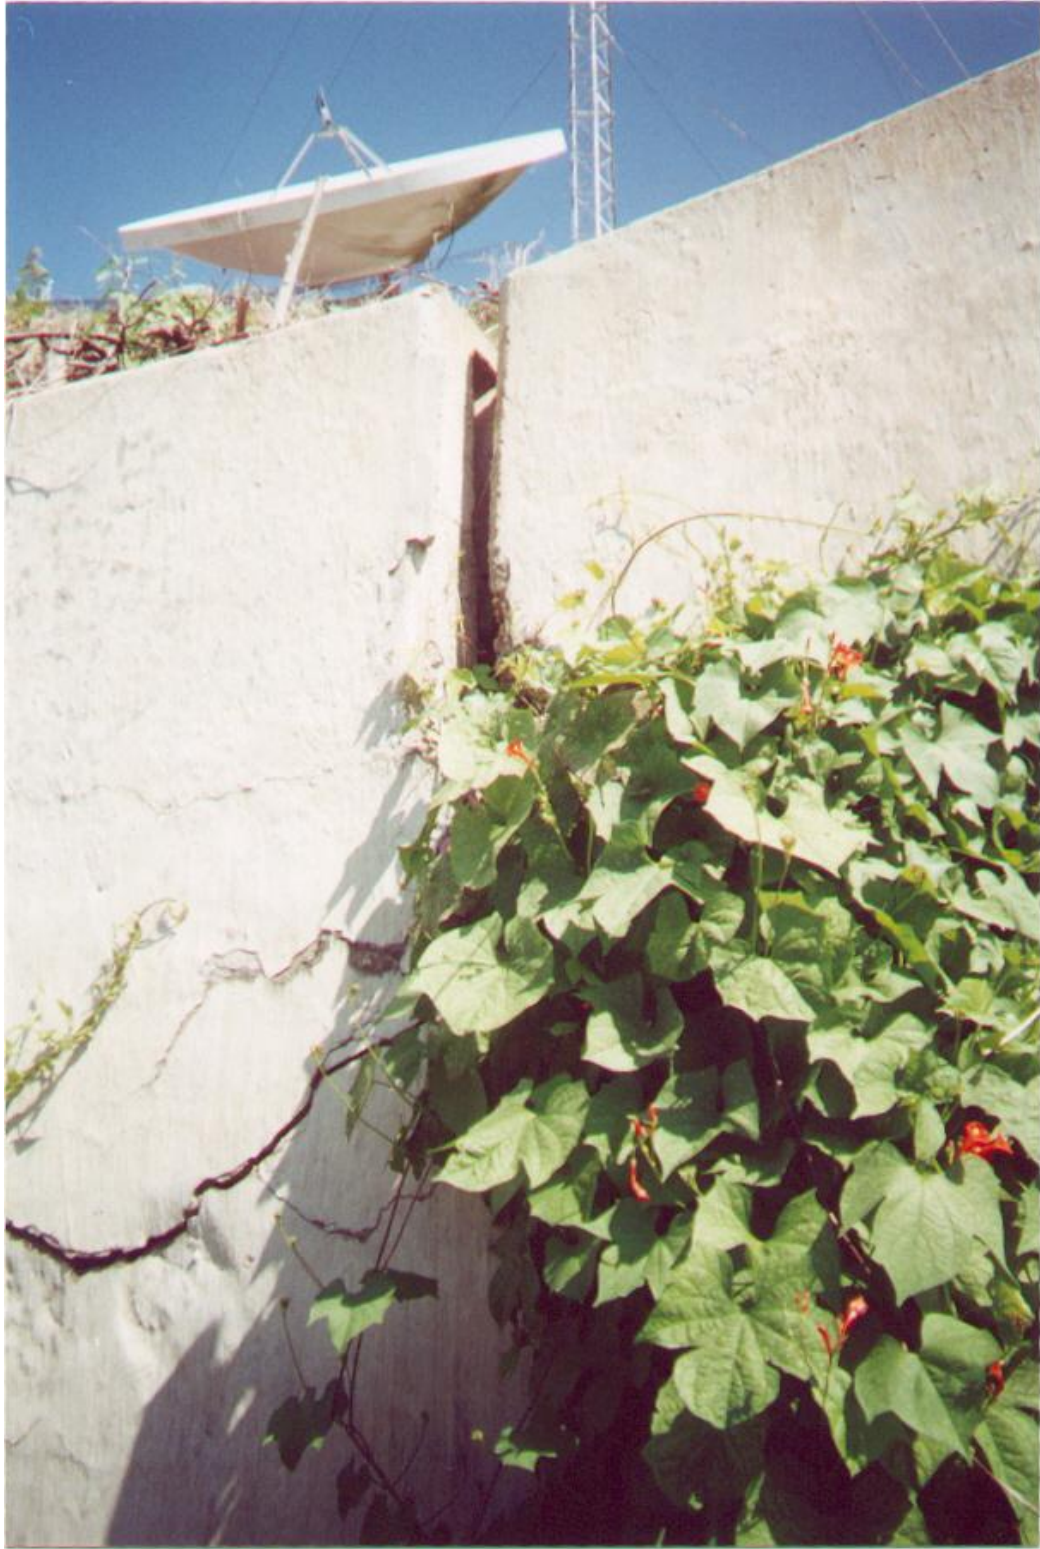
Figure 7

Separation of concrete blocks that crown the Nutt Street wall.

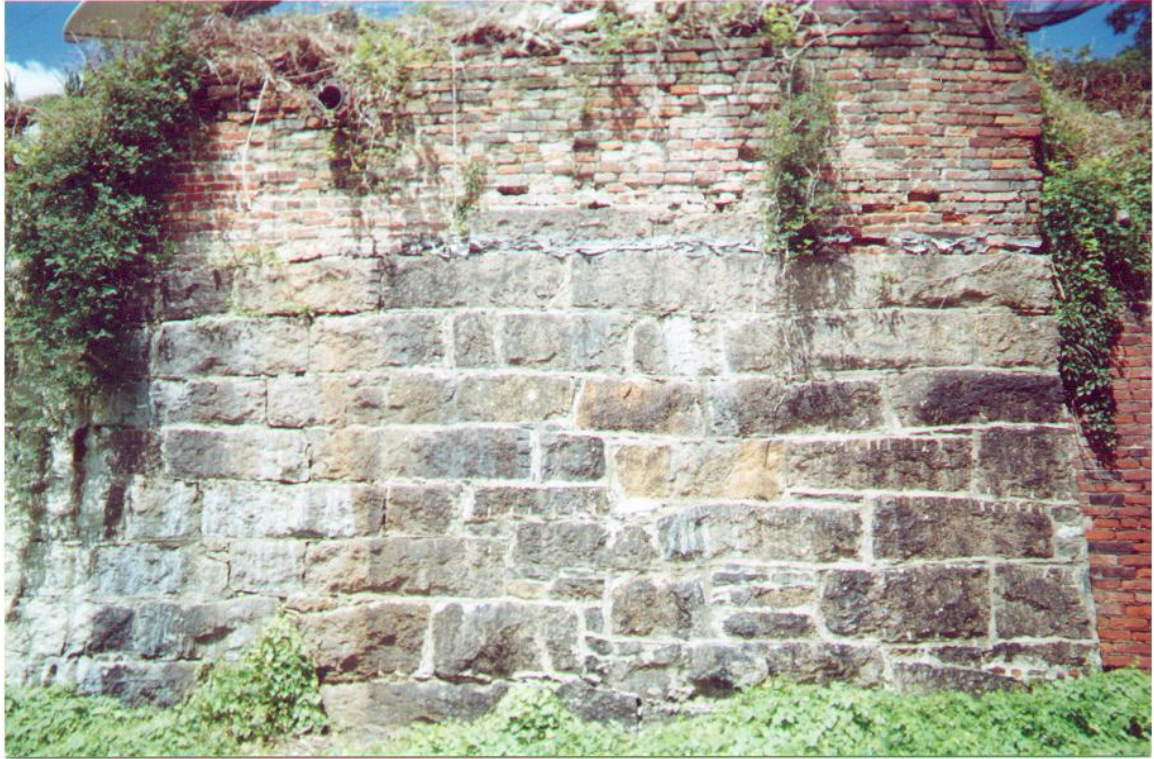
Figure 28

Note that the stone wall has been repaired with bricks above and brick fragments in the cracks below.

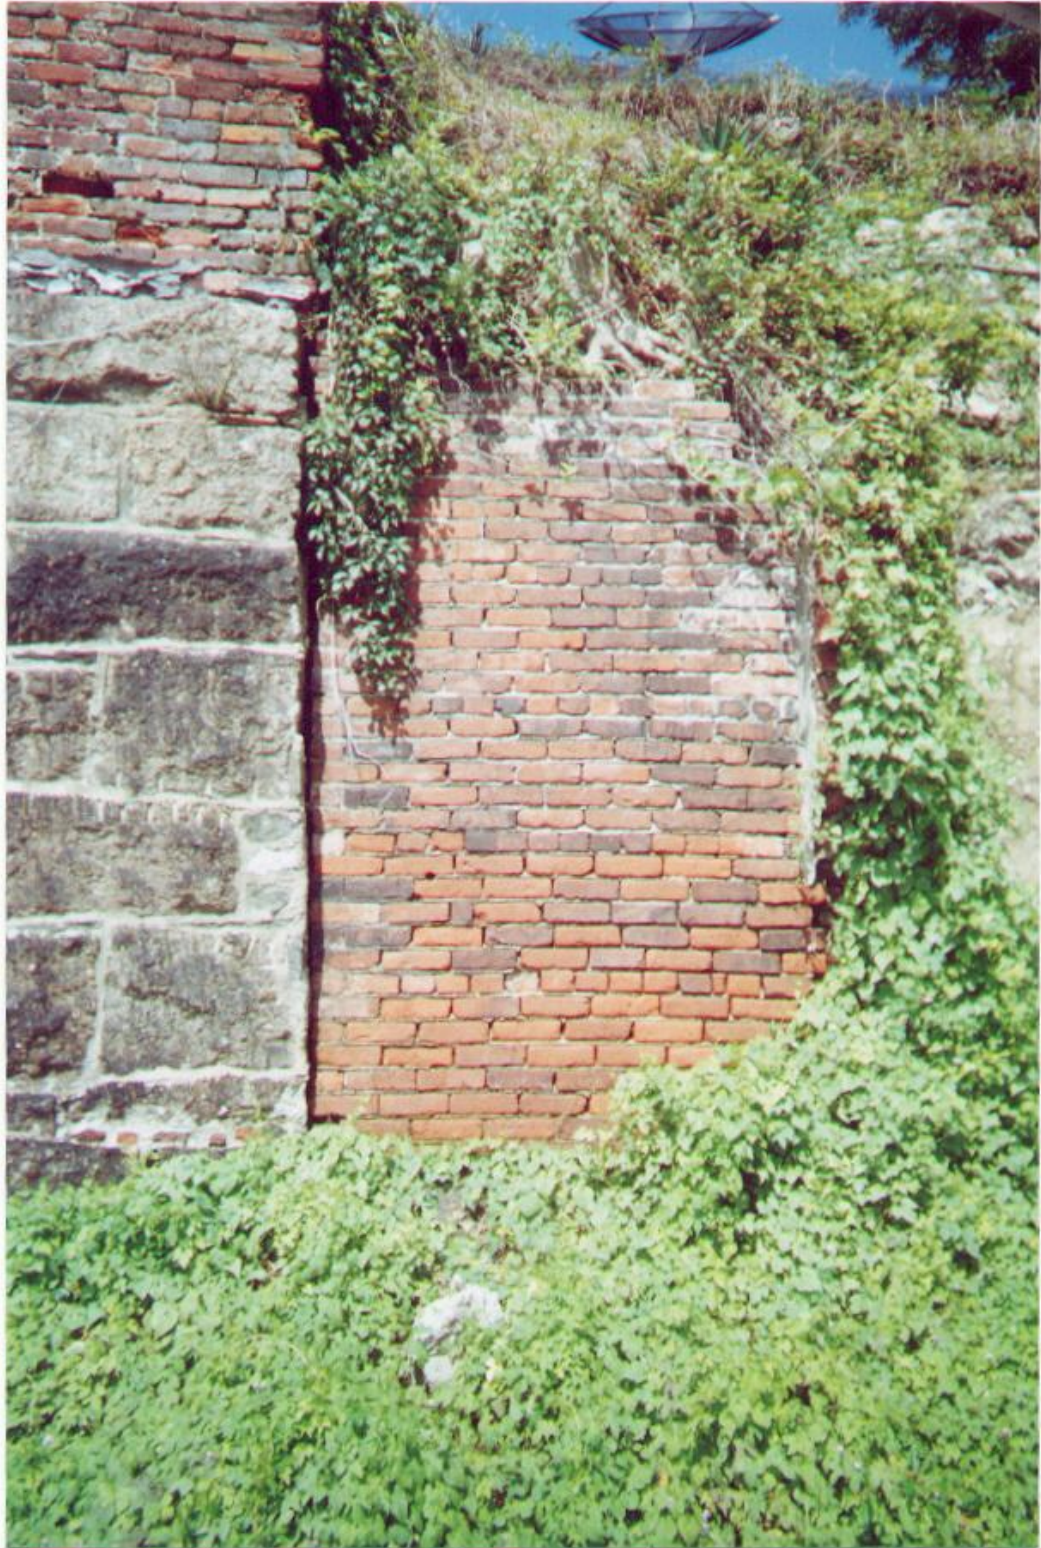
Figure 29

This is a close-up of the repair work of the stone wall. Note blackening of the stone wall.

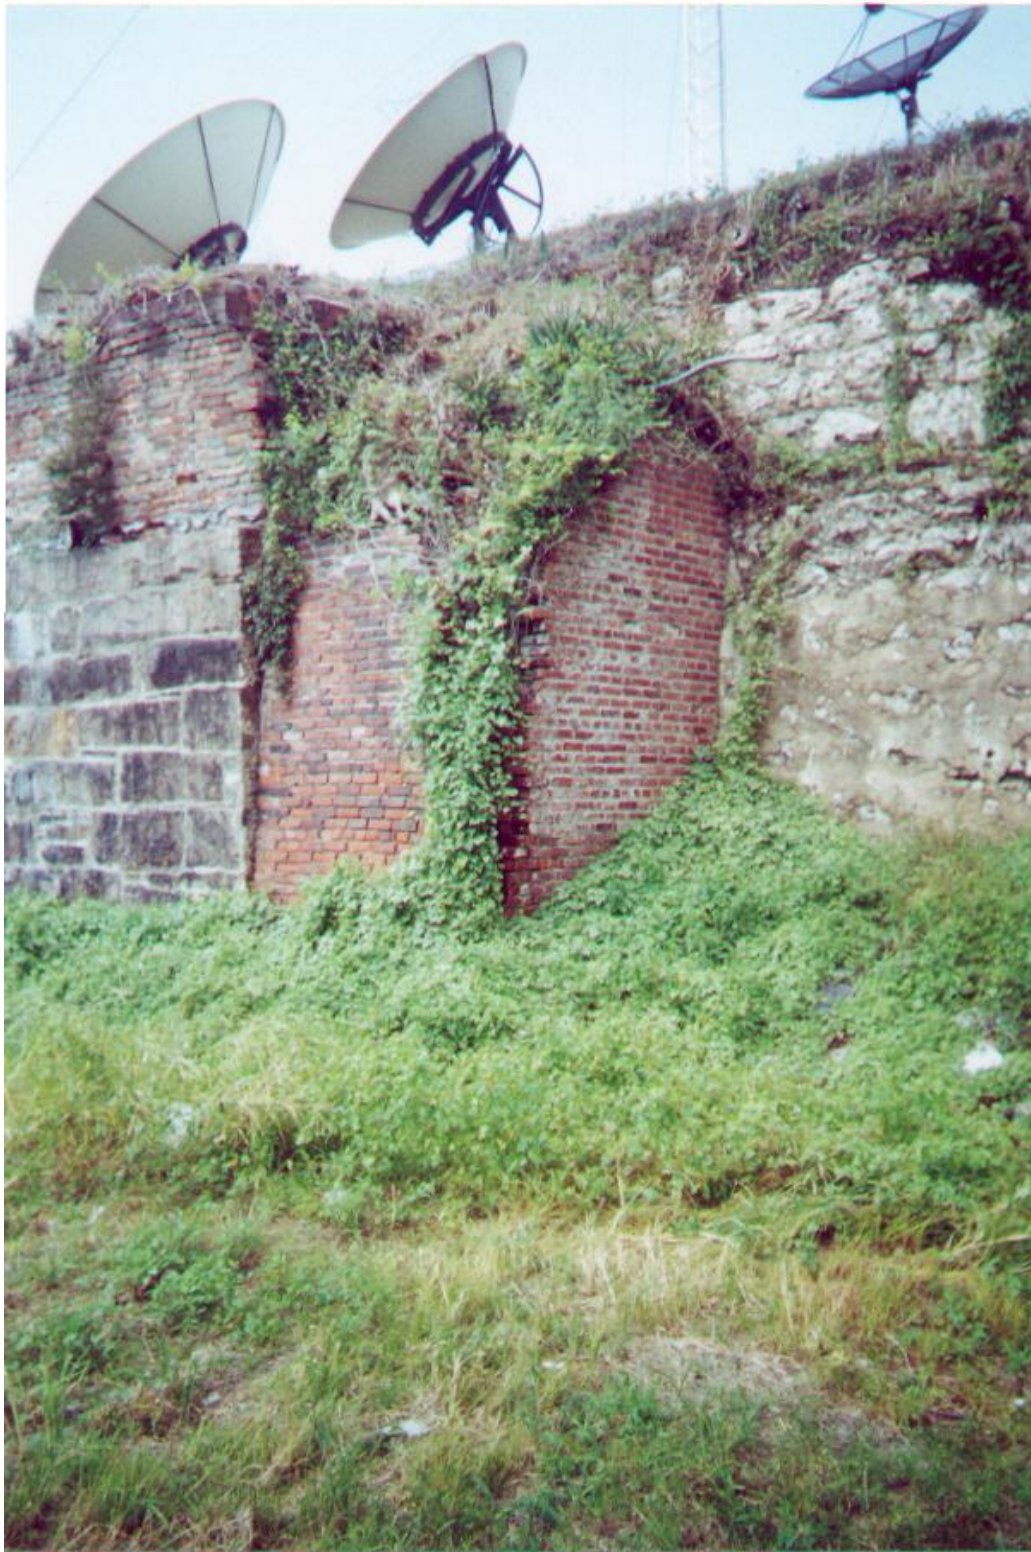
Figure 31

The brick walls are shifting apart.

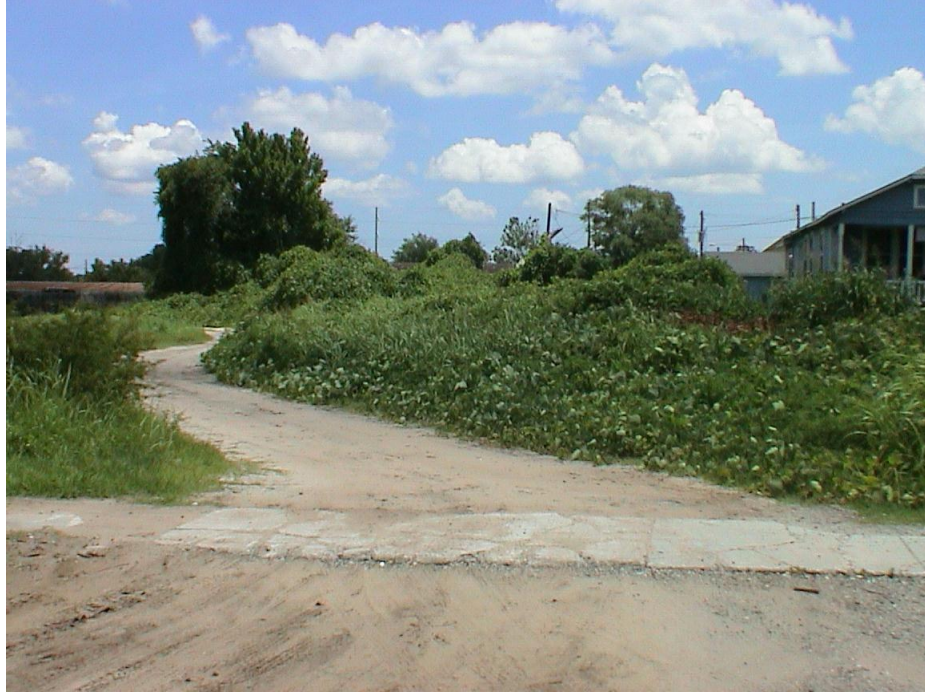
Figure 78

The pavement on McRae Street is patched where tracks once crossed the street.
